# SERVICE No. 811A BULLETIN

Piper Aircraft Corporation  
Vero Beach, Florida, U.S.A.

Date May 12, 1986 S/M

Ammeter Replacement

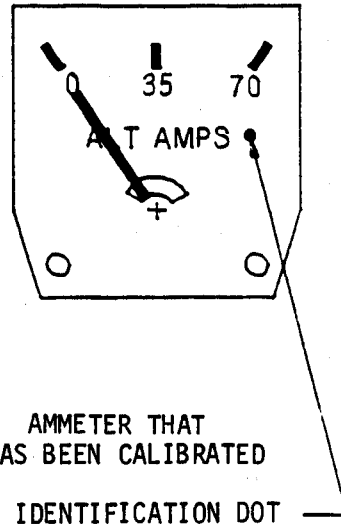
SKETCH "A"

PURPOSE: Engineering tests have determined that a number of ammeter gauges shipped in support of Service Bulletin No. 811 were not correctly calibrated. Correctly calibrated gauges may be identified by the presence of a white dot located on the righthand side of the ammeter face, immediately following the word "AMPS". See Sketch "A" attached. Incorrect ammeter indications could lead to inadvertent overcharging and/or depletion of the aircraft's battery with subsequent loss of battery electrical power.

AMMETER THAT HAS NOT  
BEEN CALIBRATED.  
NOTE ABSENCE OF IDENTIFICATION DOT

AMMETER THAT  
HAS BEEN CALIBRATED  
IDENTIFICATION DOT

1. All aircraft which have complied with Service Bulletin No. 811 must inspect for the presence of a white dot on the righthand side of the ammeter face. See Sketch "A" attached.
2. If white dot is not present, the ammeter gauge, only, must be replaced with a correctly calibrated gauge.
3. Using applicable instructions for the Ammeter Replacement Kit, Piper Part Number 765-186, replace the newly installed ammeter only, with Ammeter, Piper Part Number 763-053.
